Observed and Predicted Pier Scour in Maine

Water-Resources Investigations Report 02-4229

By Glenn Hodgkins and Pamela Lombard

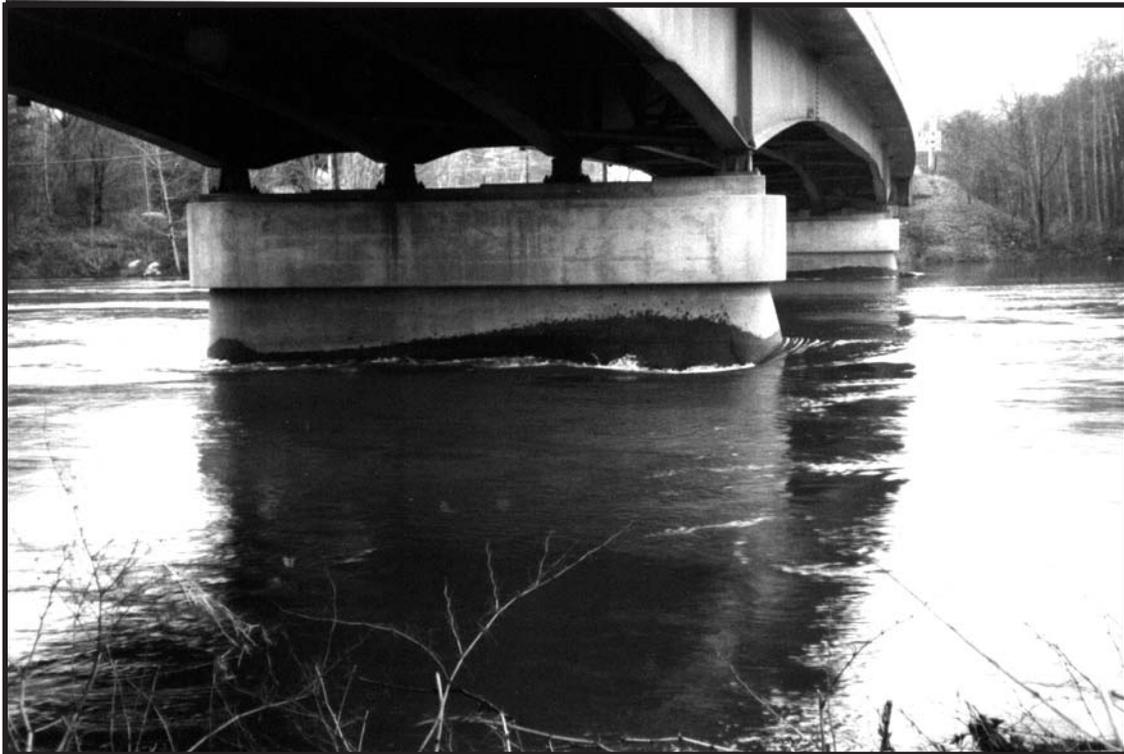
Figure 3. River flow near bridge piers on Androscoggin River at Bethel, Maine, April 1, 1998.

section. Additional depth measurements were then taken near piers, with 100 lb to 300 lb of weight (fig. 2), usually in a 2-ft grid, until the person making the measurements was confident that the maximum scour near the nose of the pier had been measured. River-height measurements, from a local datum, were taken before, during (if necessary), and after the river flow and depth measurements. Photographs were taken of the flow conditions at the bridge, around the piers, and in the upstream and downstream channel (figs. 3-4).

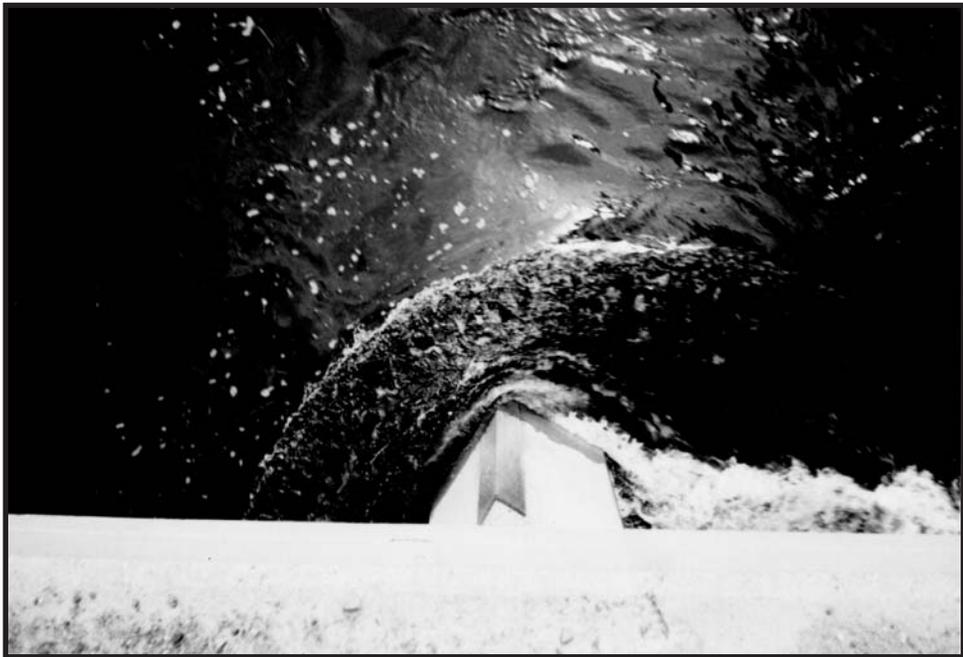
Figure 4. Flow turbulence at the upstream nose of the right (looking downstream) bridge pier at Aroostook River at Ashland, Maine, April 25, 2000.

When piers are skewed to the direction of the flow, the maximum scour depth can be located along the sides or downstream from the pier. In this study, two sites (Aroostook River at Ashland, Maine and Austin Stream at Bingham, Maine) had a pier to flow skew angle greater than 10 degrees. The maximum observed scour at these piers either was along the side of the pier or near the nose. The remaining six bridges had skew angles of 0 to 10 degrees. The maximum pier scour at all of these six bridges was near the nose of the piers, based on measurements before, during, and after high-flow measurements.

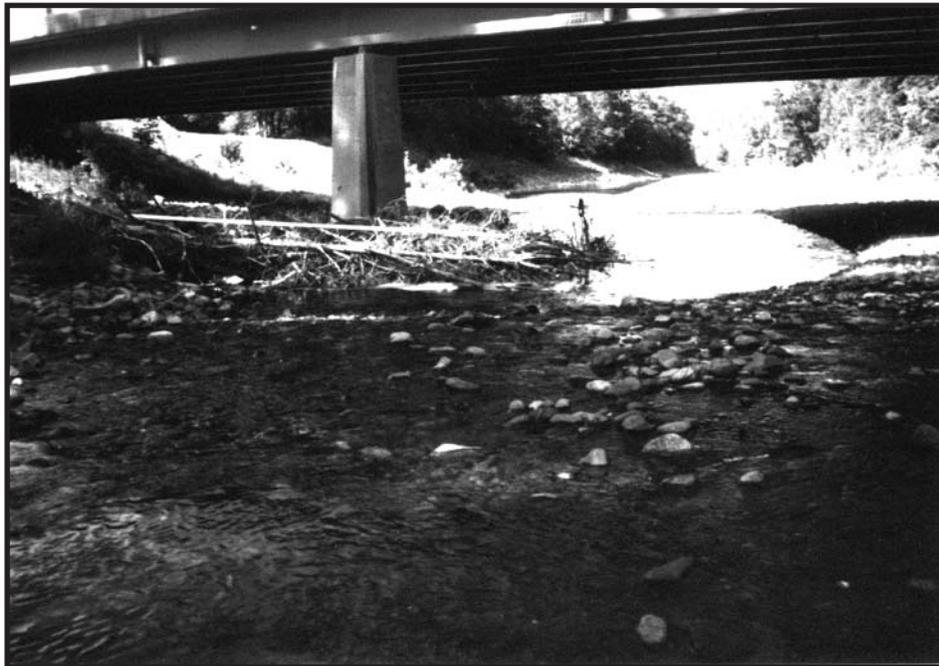
Figure 7. Woody debris accumulation on upstream nose of left (looking downstream) bridge pier at Austin Stream at Bingham, Maine, June 28, 2000.

Pier scour associated with debris lodged on a pier was observed at two sites in this study (Saco River at Hiram, Maine; Austin Stream at Bingham, Maine). At both sites, the debris lodged on the piers after a high-flow scour measurement was made. No substantial debris was observed on any piers during any high-flow measurements in this study. Surface accumulations of debris are visible during high flows. Sub-surface accumulations can be observed when sounding near a pier.
